Reinforcement Work on the Main Building of the Bank of Japan's Head Office

1. Introduction

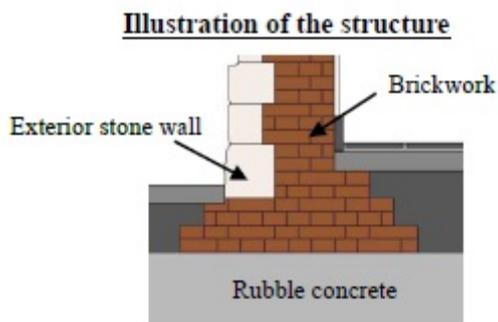
The Main Building consists of a brick foundation with stone walls: stone blocks for the outer walls and bricks for the inner walls are piled on top of each other, without the use of any steel reinforcement bars or steel frame. In addition, the building stands on a thick, strong concrete slab, a foundation called "rubble concrete."

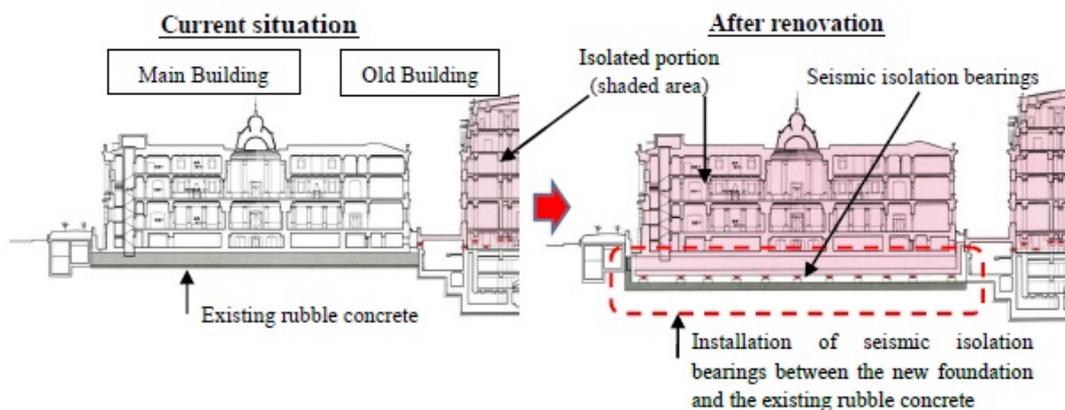
It was decided to take advantage of this feature in the reinforcement work, by keeping the rubble concrete, creating a layer of space around it, and laying a new foundation under that layer of space, with seismic isolation bearings installed in the space between the new foundation and the rubble concrete, seismically isolating the Main Building -- including the existing rubble concrete foundation -- completely from the new foundation.

This is called under-foundation base isolation (seismic isolation retrofit) and examples of its use in the base isolation of important cultural properties are beginning to be seen. However, according to the design contractor, this will be the first time that an historic building as big as the Main Building, with a total floor area in excess of 10,000 m², has been completely seismically isolated along with its existing rubble concrete foundation.

- ☞ More than 100 seismic isolation bearings will be installed under the Main Building, supporting its 75,000-ton weight (twice the total weight of all the steel frame used in Tokyo Skytree) from below.

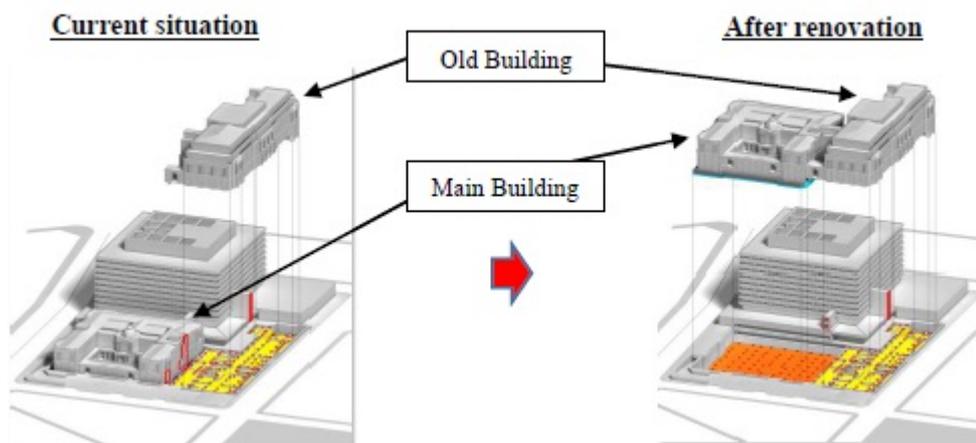
As the seismic isolation bearings being installed under the Main Building are separate from those already installed under the Old Building, there is a risk that, in the event of a major earthquake, the two buildings could suffer damage from colliding with each other. Therefore, a strategy has been devised to avert this risk by firmly connecting the Main Building to the Old Building with complete seismic isolation of the adjacent Old Building and Main Building as a single unit.

Although examples of the base isolation of multiple new buildings connected together have begun to be seen in projects where this procedure has been planned in advance, the Main Building is the first example of seismic isolation of a building in conjunction with an existing seismically isolated building (the Old Building), according to the design contractor.

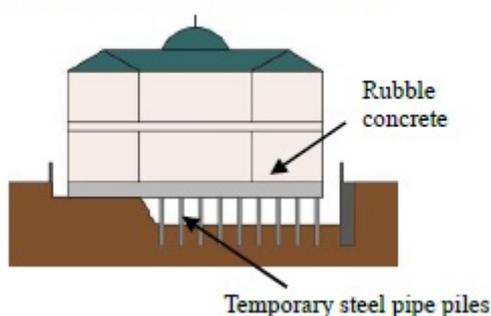
Illustration of the steel pipe piles

Various strategies are being adopted with this in mind in the reinforcement work. For example, the Main Building is, of course, being supported by a multitude -- as many as 500 in total -- of sturdy steel pipe piles. In addition, the excavation area has been subdivided and the order in which excavation is carried out has been carefully calculated.

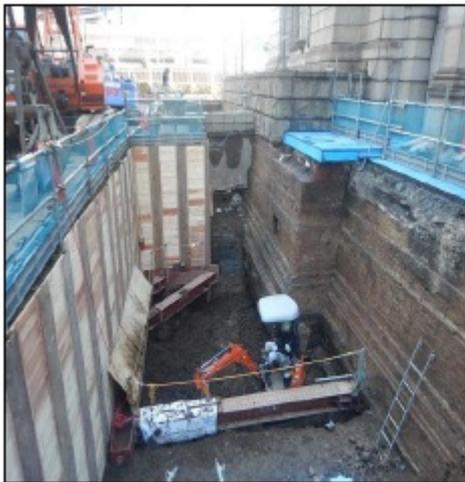
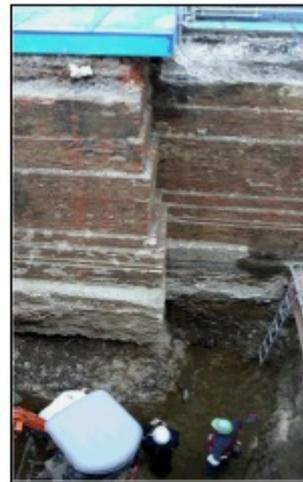
Excavation carried out in the front yard

The reinforcement work, which began in the autumn of 2016, began with the excavation of the area around the outside of the Main Building. This will be followed by excavation underneath the Main Building, the construction of the new foundation, and the installation of the seismic isolation bearings. Finally, the Main Building and the adjacent Old Building and New Building will be connected, with the whole project due to be completed in the summer of 2019.
